## Fire Down Below

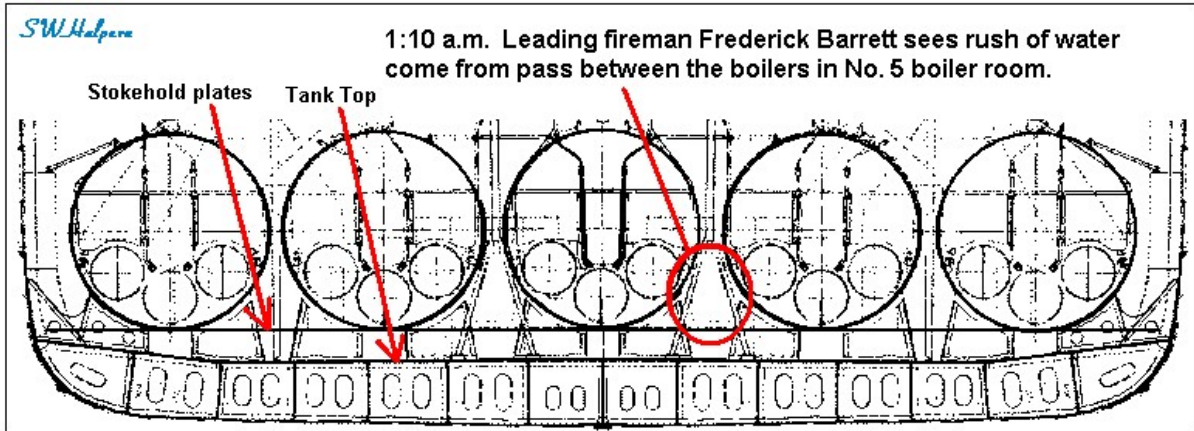
Fires were also drawn from the furnaces in No. 5 boiler room that night. When that task was completed, the men working there were sent up except for Barrett. As a leading fireman, he was asked to remain below to open a manhole plate on the starboard side so the engineers could get at some valves in the piping system. Being thick with steam from all the water that was thrown onto the fires in the furnaces, Assistant Second Engineer Jonathan Shepherd did not see the open manhole and fell in and broke his leg. Barrett and another engineer, Herbert Harvey, lifted Shepherd out and carried him aft to the pump room where they attended to him as best they could for a while. About 15 minutes later, according to Barrett, “a rush of water came through the pass - the forward end, a space between the boilers where we walk through...I never stopped to look [where the water came from]. I went up the [escape] ladder. Mr. Harvey told me to go up.” When Barrett was asked if it could have been a bunker bulkhead at the head of the compartment that gave way, he replied: “I have no idea on that, but that is the bunker that was holding the water back.”

Fig. 6-30 Frederick Barrett sees water coming from pass between boilers.

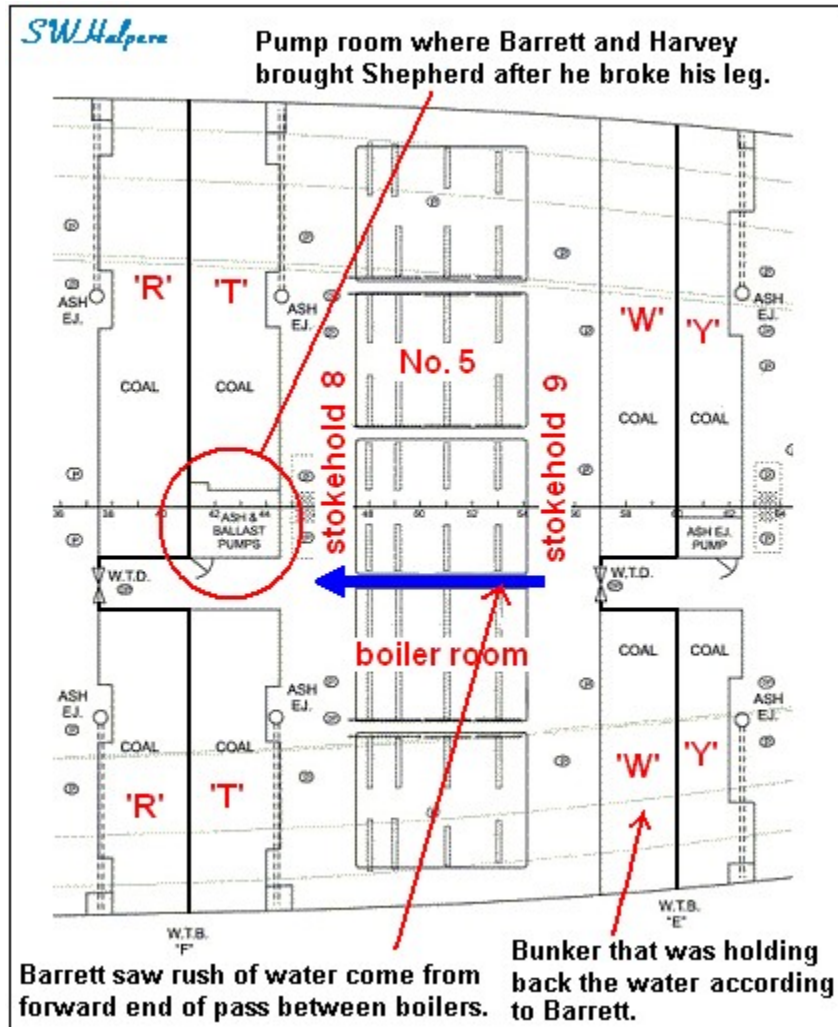
Fig. 6-31 Rush of water between boilers in No. 5 Boiler room.

The most likely cause of that rush of water seen by Barrett was the collapse of a bunker door on the bunker bulkhead at the forward starboard side of No. 5 boiler room. As noted before, water was seen entering that empty bunker space from the time the collision took place. Taking into account the capacity of the transverse bunker space and allowing for some remaining coal, a build up of about 440 tons of sea water could easily have filled that space between the tank top and F deck if gone unchecked. We know that water was seen falling down the first class staircase from E deck onto F deck as early as 12:50am by steward Joseph Wheat; a location that was a good 60 feet aft of where watertight bulkhead E, between No. 5 and 6 boiler rooms, was located. There very well could have been sufficient down-flooding into that forward cross bunker to create a sufficient pressure head even with water draining out of 4 very small drain holes at the

bottom of the bunker bulkhead, especially if any coal or debris still remained in the bunker to impede the flow through those holes onto the plates of the tank top. The bunk doors on the bulkhead were not designed to be watertight, nor designed to hold back a large force pushing against them. If water had reached a height of just 10 feet over the stokehold plate level in the bunker by that time, it would have created a total force against each bunker door of about 3 tons. These bunker doors slid in thin channels that were only ½ inch wide. If a bunker door gave way as a result of a pressure head of about only 10 feet, the velocity of water that would come bursting out of the bunker would be close to 25 feet per second, easily creating “a wave of green foam coming tearing through” into the walk space between the boilers. If it were the main watertight bulkhead between the two boiler rooms that failed, Barrett would not have had time to reach the escape, let alone hear engineer Harvey order him up.
