Where Did That Water Come From?

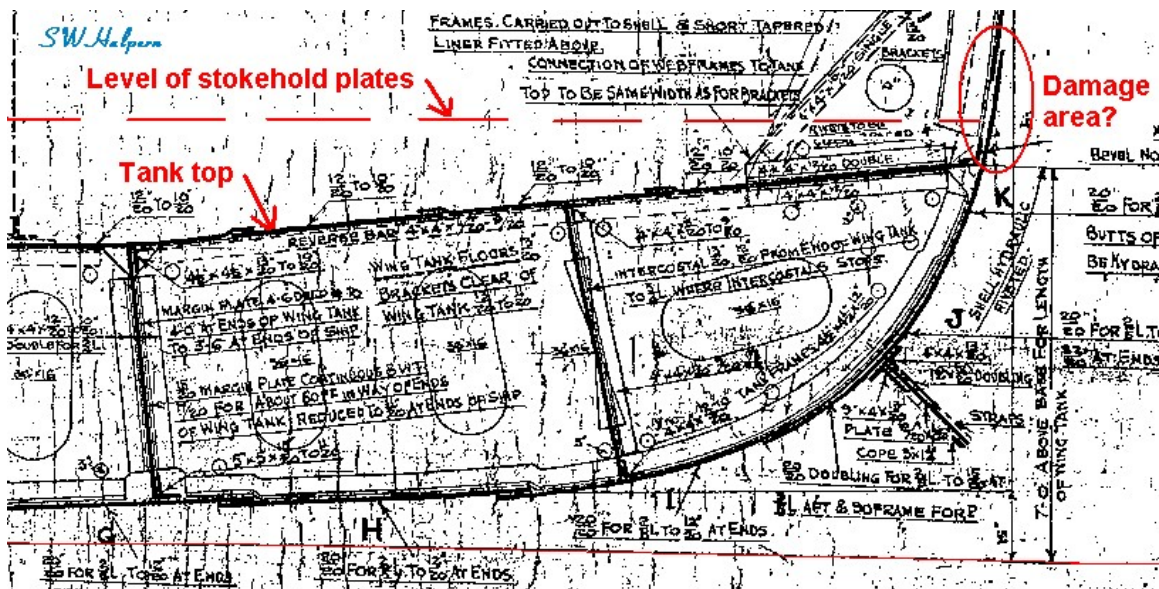
Where did this water come from? For most of the time BR 4 looked apparently dry to those working the furnaces. The boiler room just ahead, BR 5, had water coming in from the starboard side of the ship in the forward bunker from about 2 feet above the stokehold plates; about what would be expected from an ordinary fire hose according to leading fireman Frederick Barrett. The watertight door to that room, between BR 4 and BR 5, and all those ahead of it, remained shut since the time of the collision. Could it also be that there was some small amount of collision induced damage in BR 4 which, though mostly unnoticed, caused water to come in above the level of the tank top by the ship's side where the tank top and stokehold plates tend to converge as shown below? And if this were the case, can we quantify the extent of such damage?

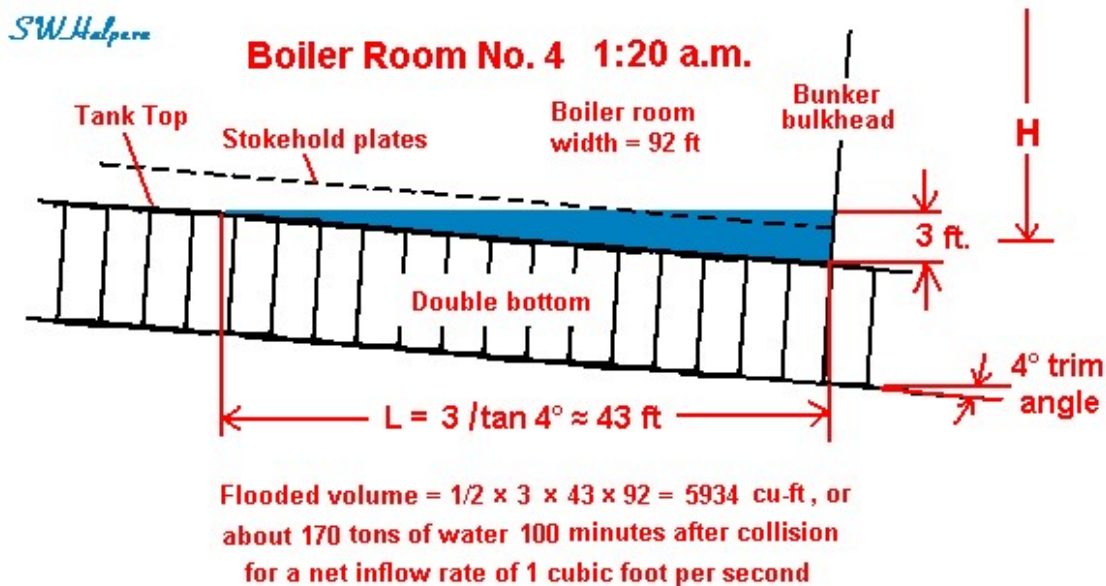
The answer can easily be derived from the information that we were given. We will take the situation at 1:20 a.m., 100 minutes after the collision. We will assume that in the forward part of BR 4 water had risen to 3 feet above the tank top bringing it above the stokehold plates as observed by Cavell. Due to the ship being trimmed down by the head, we will take the average height (H) of water to be about 35 feet from the surface to an assumed damage point just above the tank top on the starboard side. By 1:20 a.m., the trim of the ship had reached about a 4-degree down angle. The width of the boiler room was 92 feet.

As shown in the diagram above, we can easily calculate the volume of water that was seen in the room 100 minutes after the collision. This comes out to 5934 cubic feet, or just about 170 tons of water. However, there is evidence that the engineers became aware that water was coming into this boiler room earlier on because they asked for a portable suction-pipe, which was stored aft in the last shaft tunnel compartment, to be carried forward into the stokeholds. To do that they needed to get all the watertight doors aft of the engine room raised. According to greaser Frederick Scott, he and others were ordered to open all the doors aft about an hour after the collision (BI 5600-5604). Given 15-20 minutes to get 4 doors cranked all the way up, it would be about 1 a.m. that the portable suction pipe was first carried forward into the stokeholds. Scott, like Dillon, said he was ordered up on deck at 1:20 a.m.

when Dillon and two others were sent to open the watertight doors forward of the engine room. The amount of water that these two pumps would draw out of BR 4 (from 12:10 a.m. to 1:20 a.m.) would have been about 467 tons. It is also assumed that the portable piping that was brought forward after the doors aft were opened up was still being connected up to augment those pumps when Cavell and Dillon had left the scene. So by 1:20 a.m. there would have been about 170 tons of water that came into the compartment that was unchecked while 467 tons was already pumped out. Therefore, the total amount of water that would have come into the compartment is $467 + 170 = 637$ tons in 100 minutes. **And 637 tons in 100 minutes is an inflow volume rate of 3.7 cubic feet of water per second.**

where **g** is the acceleration of gravity (32 ft/sec/sec) and **H** is the height of the water head taken here at an average of $H=35$ ft. This works out to 47.3 ft/sec. If we divided the volume flow rate (3.7 cu-ft/sec) by the inflow velocity (47.3 ft/sec), we get the size of the area of the opening in the hull. This comes out to be 0.079 square feet, or 11.3 square inches of opening; the same as **a split in a seam of only 5/16 inch taken over a length of 3 feet**, the length between two adjacent frames.
