Appendix G

SOCKET DISTRESS SIGNALS IN 1912

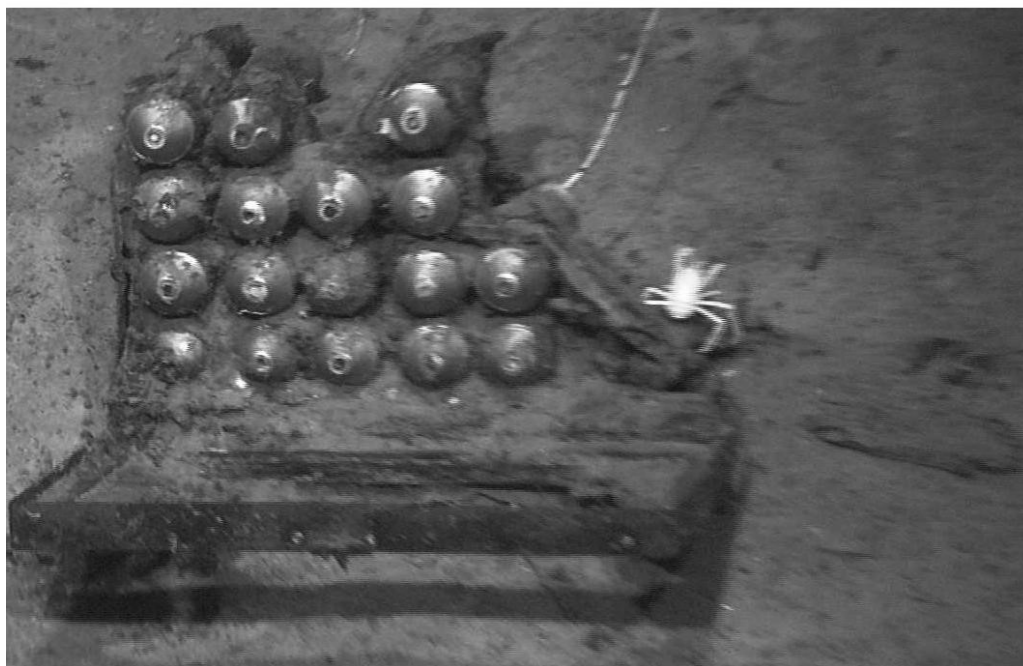
An opened decaying box containing 17 unfired distress signals was found on the seabed at the *Titanic* wreck site. It was apparently large enough to easily hold 4 rows and 6 columns worth of these signals, or a total of 24, plus room to hold the firing lanyard, cleaning hook, and friction tubes needed to fire the signals. As can be seen in the photograph shown in Figure G-02,³ there appears to be a great amount of corrosion and marine growth in what is left of the box. The distinctive shapes of the socket signals themselves are easily recognized. The hole in the center of their conical shaped heads are the top end of a long brass tube that ran all the way down the center of the signal to a powdered charge in the signal's base. According to *Titanic*'s Second Officer Charles Lightoller, the hole down the center came blocked up with a peg. This would be removed prior to firing, and a friction tube would be inserted into the brass tube as far down as it would go. Then a lanyard would be hooked to a wire loop at the top end of this friction tube. When this lanyard was pulled, it would fire the charge in the signal's base and light a timed fuse. The shell would then be propelled to a height of about 600 feet where it would burst "throwing out a great number of stars."

Fig. G-02. Box of signals found at the *Titanic* wreck site.
